## Case # BZA-07-25-00886 Charleston County BZA Meeting of September 8, 2025

**Property Location:** 3517 Maybank Highway – Johns Island

Variance request to remove a 28" DBH Grand Live Oak Tree for proposed mixed-use development.

### **Arborist Report**

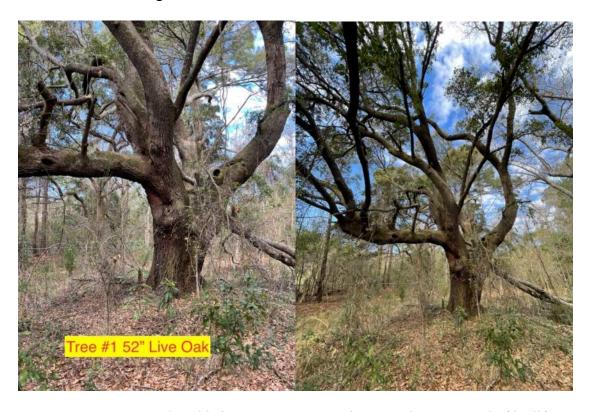
Tree #1: 52" Live Oak. This tree has some older damage in the trunk and main leads of the tree canopy with some decay but healing over in most instances. The canopy is in average condition with average leaf size, color, canopy coverage. There is more canopy coverage on one side (west) because of water oak adjacent shading sunlight to canopy and evident of growth over time. This tree is in Average health and condition for a tree of its size and age. **Grade C**

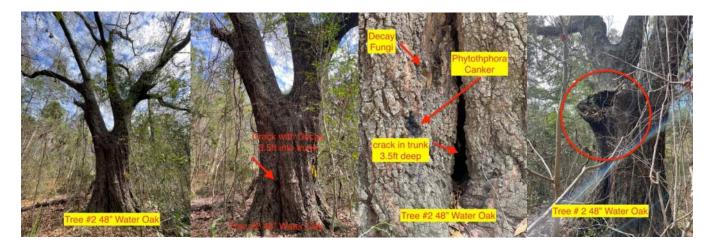
Tree # 2: 48" Water Oak. This is a mature water oak tree at the upper end of its life expectancy. This tree has a large cavity in the main trunk of the tree up approx.. 7-8ft high. this is an old leader that broke out and there is a large area of decay in this area. There is significant large limb and storm damage breakout in the canopy of this tree with several areas of decay in limbs and leaders from 6" diameter up to over 20" diameter in main leads and the main trunk of the tree. There are bleeding cankers on the trunk of the tree. There are decay fungi on the trunk and main leads showing active decay. There is a crack in trunk of the tree with a

large cavity at the base that I measured at 3.5ft void in the base of the trunk at the flare. Major structural decay and rot in this tree and is a liability to build or plan around. **Grade D**

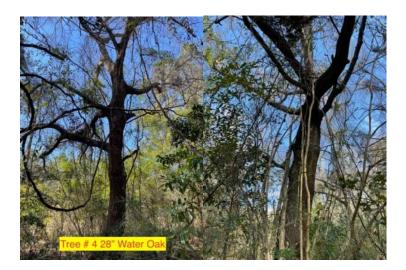
Tree #4 28" Water Oak. This tree has a lean in the trunk towards the east. The canopy and the most of the limbs in the tree have growth towards the west. There is some old damage at the base of the tree that has callused over and healed for the most part and no visible cavities in the base at this time but evidence of old damage in the trunk. There are also vertical seams/cracks in the trunk of the tree that have healed over also. This evidence suggests that there has been windload event that has caused cracks in the trunk that has healed over and could be some decay or hollow in the trunk not visible from the outside. There is some vine competition in the canopy, the canopy is in less than average condition with its growth and vines. There are

also dead and storm broken limbs in the canopy. Tree is in lower than average condition Grade C-

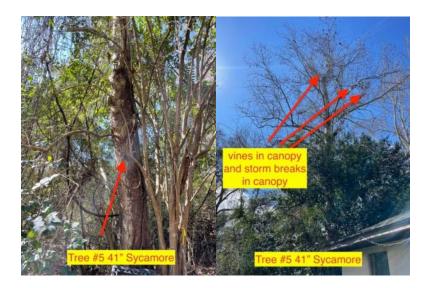
Tree #5 41" Sycamore. This tree is a Sycamore and not an oak tree, incorrectly labelled. This tree has lots of vine competition in canopy growing and choking out the canopy of the tree. There are several lower sucker/epicormic sprouts on the base of the tree, a sign of poor health. The tree has several areas of storm breaks in the canopy of the tree in major leads/portions of the canopy. This tree has tremendous stem taper very large at base and about 20ft high it is approx.. 20"-24" diameter, this tree has built lot of stem taper my guess from the continued vine competition causing swaying in the wind when vines have leaves. This tree is in less than average health and condition. **Grade C-**

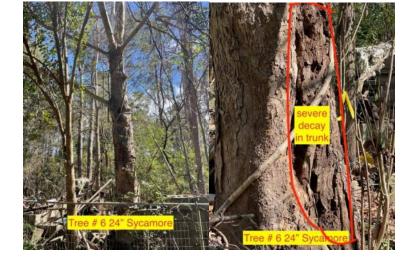
Tree #6 24" Sycamore. This tree was mislabeled as an oak, it is actually a Sycamore tree. This tree has a major structural defect in the trunk of the tree from ground level up approx.. 8ft tall. Severe decay reaching approx.. 40-50% of the base of the tree and sapwood rot and heartwood rot and it is not callusing over. Severe structural defect in main load bearing portion of the tree. This tree is a liability to plan or build around recommend removing this tree. **Grade D**

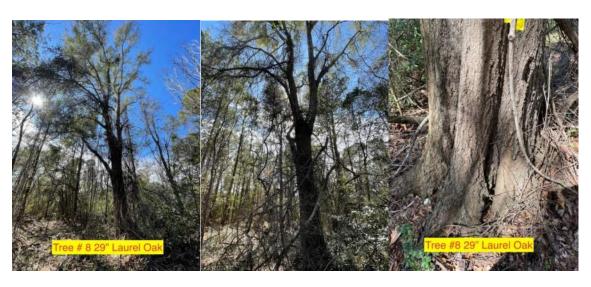
Tree #8 29" Laurel Oak tree. This tree is upright in form. It has been pruned by electric company as it is close to the existing power line easement and has very little growth on the side of the power line and more canopy growth away from the power line. This tree has a small cavity the trunk of the tree and seams in the base of the trunk at the root flare. there is also some areas of inactive older phytothphora cinnamomi cankers, not bleeding at this time because of time of year (some trees are active, some are not and may be in a few weeks). This tree has ok canopy growth but is one sided. The defects in trunk are minor (not major). This tree is overall in less than average condition. **Grade C-**

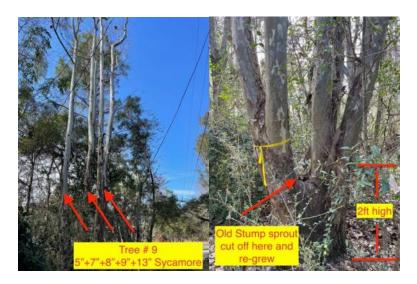
Tree #9 (5"+7"+8"+9"+13" Sycamore Tree). This tree should not count the 5" and 7" stems as only 8" trunks should be considered in "grand tree" sizing. This tree is an old stump sprout. There is an obvious location at approx. 2ft height where the tree was previously cut some years ago and the epicormic root sprouts grew from this location up to form this tree. All of these stump sprouts have severe "Included bark" and are very weakly attached at this old basal cut location. This is a tree that will not be sound when the site is cleared and windload is introduced to this tree, the individual tree trunks that are very small, and very tall will be very susceptible to wind damage and failing at the location (at the base of the tree) where the included bark is located. This tree could be a liability and most likely has not failed to this point because of the adjacent tree canopy protecting it from true wind load potential. I would not recommend saving this tree or planning and building around it. **Grade D**

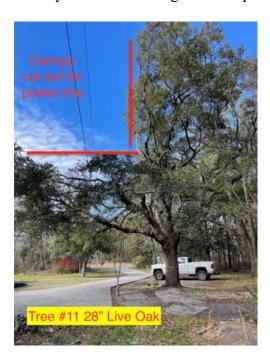
There may be extraordinary and exceptional conditions pertaining to the approximately 3-acre property. The Arborist's report states the 28" Live Oak (Tree # 11) "has had severe pruning over years from the electric company. It has approx. 25%-33% of its canopy pruned out for the utility overhead line. It has many stubs and areas of injury/healing in this ½ of the tree close to the power line. There are some areas of decay and cuts that have not callused or healed over. There are several areas of stubs and epicormic sprouts, areas trying to heal over but not, this tree is in less than average condition." The Applicant's Arborist graded the tree C-. The County Arborist graded the tree C+.

Tree #11 28" Live Oak. This live oak has had severe pruning over years from the electric company. It has approx.. 25%-33% of its canopy pruned out for the utility overhead line. It has many stubs and areas of injury/healing in this ½ of the tree close to the power line. There are some areas of decay and cuts that have not callused or healed over. There are several areas of stubs and epicormic sprouts at these pruning locations. The tree canopy in the rest of the tree that has not been pruned for power line is in average condition. Given the years of pruning, cuts, healing or lack there of, epicormic sprouts, areas trying to heal over but not, this tree is in less than average condition. **Grade C-** Worth noting...If it were my property I

- 1. Prior to zoning permit approval, the applicant shall complete the Site Plan Review process.
- 2. The applicant shall mitigate the removal of the 28" DBH inches by either (a) submitting a mitigation plan for review and approval indicating the installation of canopy trees no smaller than two and one-half (2.5) inches in caliper equaling inch per inch replacement, (b) by depositing funds into the Charleston County Tree Fund as described in Sec. 9.2.6 of the ZLDR, or (c) a combination of both (a) and (b). The allotted mitigation shall be in place prior to its removal.

would propose removing this tree, but keeping the 10 live oak hearby and adjacent to the 30 live oak in replacement (or mitigation) of this tree to have a tree in better health and overall the same or better canopy in future years with building or development on this project.

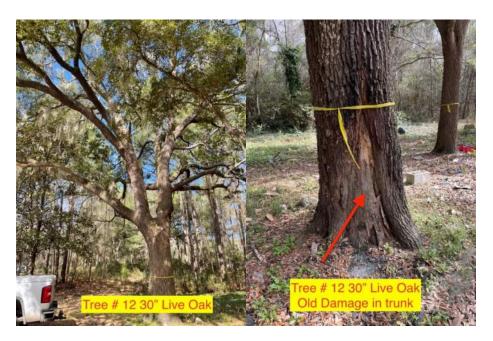
Tree #12 30" Live Oak. This tree is in overall average to above average condition. There are not any major cavities or decay in the base of the tree, however there is an area of old damage to the trunk but it is callusing over and healing without signs of decay at time of inspection, if not for this single issue the tree would receive a higher mark. The leaf size, color, and distribution is in good condition. The overall canopy size and coverage is above average for a tree of size and location. **Grade B-**

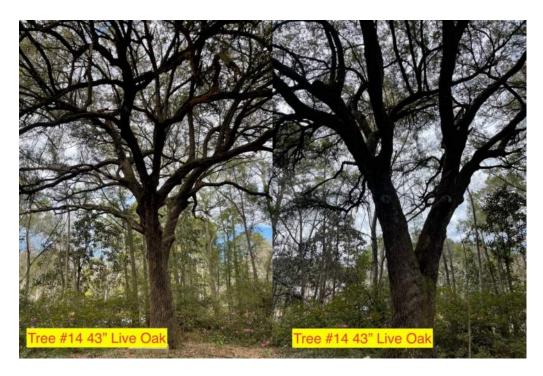
Tree #14 43" Live Oak, This tree is in overall good condition. It does have a co-dominant canopy up approx.. 8-10ft the main trunk splits to 2 different leaders. There is no visible decay or damage visible in the main trunk or the two bigger leaders of the tree. The leaf size, leaf color, canopy coverage, spread, tree height, etc.. are all at average or above average condition. The tree does have a decent amount of lower and interior dead limbs, common on live oaks never canopy cleaned or pruned with other tree canopies around as the lack of sunlight to lower limbs and lack of pruning causes dieback in interior and lower portions, otherwise tree would get higher marks if not for this but can be remedied with canopy clean pruning. Tree **Grade B+**

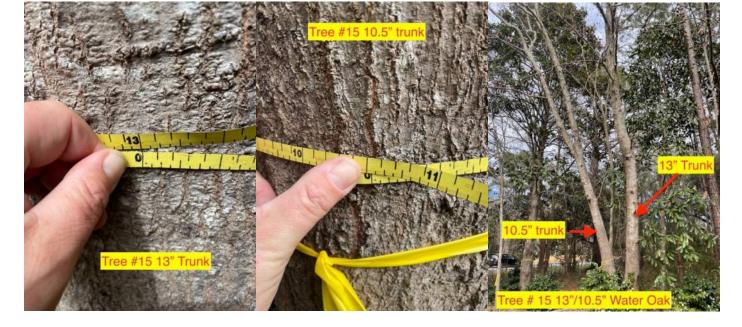
Tree #15 (10.5"+13" Water Oak). This tree was not accurately measured by surveyors. They have it marked as a 11"/15" Oak, but per diameter tape measurements it comes out to a 23.5" (10.5"+13") and should not be considered as a grand oak tree. Tree also has active bleeding canker on the 13" trunk. Tree **Grade C Not a Grand Tree per in field measurement**

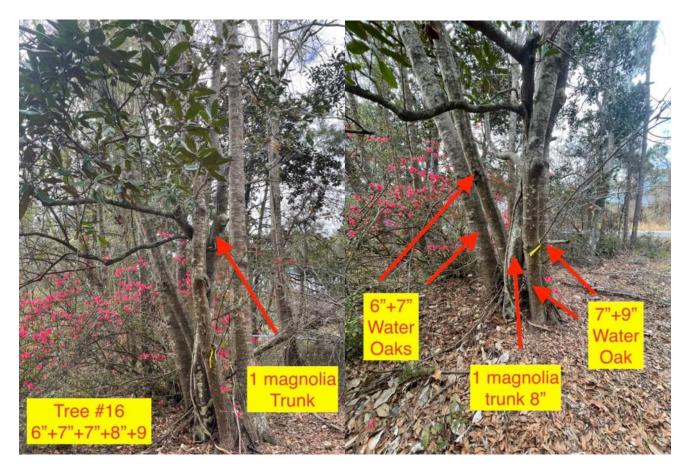
Tree #16 Actually 3 different trees. A 7"+9" water oak, A 8" Magnolia, A 6"+7" water oak. see pictures of tree there is a magnolia tree growing in the middle of 2 double trunk water oaks. This is 3 different trees one water oak, one magnolia, one water oak, that are all under size requirement for "grand tree" status and should not be considered grand trees. **Not Grand Tree**

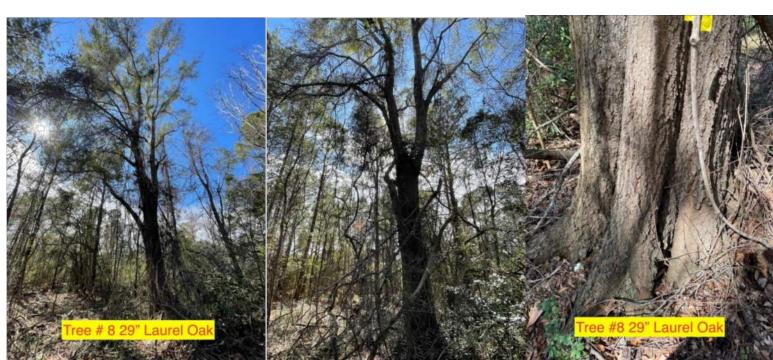
Tree #8 29" Laurel Oak tree. This tree is upright in form. It has been pruned by electric company as it is close to the existing power line easement and has very little growth on the side of the power line and more canopy growth away from the power line. This tree has a small cavity the trunk of the tree and seams in the base of the trunk at the root flare. there is also some areas of inactive older phytothphora cinnamomi cankers, not bleeding at this time because of time of year (some trees are active, some are not and may be in a few weeks). This tree has ok canopy growth but is one sided. The defects in trunk are minor (not major). This tree is overall in less than average condition. Grade C-
