## Case # BZA-07-25-00886 Charleston County BZA Meeting of September 8, 2025

**Property Location:** 3517 Maybank Highway – Johns Island

Variance request to remove a 28" DBH Grand Live Oak Tree for proposed mixed-use development.

### **Arborist Report**

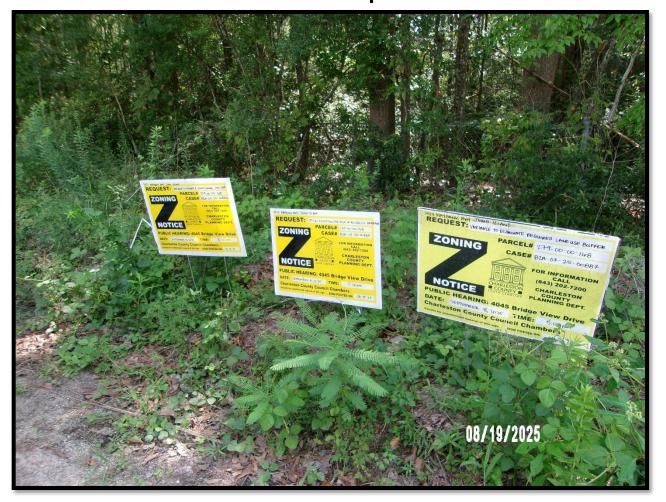
# 28" DBH Live Oak Tree

Variance to Remove
